WHITING POND DAM
MA 00859

PHASE I INSPECTION REPORT
NATIONAL DAM INSPECTION PROGRAM

DEPARTMENT OF THE ARMY
NEW ENGLAND DIVISION, CORPS OF ENGINEERS
WALTHAM, MASS. 02154

DECEMBER 1978

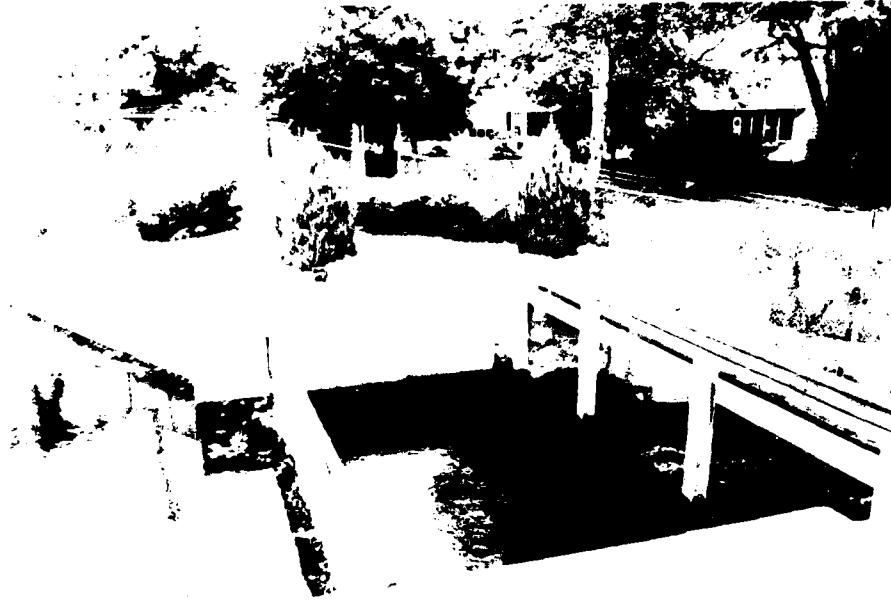
C. Appurtenant Structures. The upstream portion of the spillway walls and the adjacent platform are constructed of relatively recent vintage concrete and are in excellent to good condition, Photos No. 4 and 5. There are some minor shrinkage cracks present within the concrete. The concrete joints were either not sealed or the sealant has been lost. Sealants are required at these joints to prevent future deterioration of the structure. A trash screen constructed of chain-link fencing spans the approach channel.

4. Left spillway walls and adjacent platform

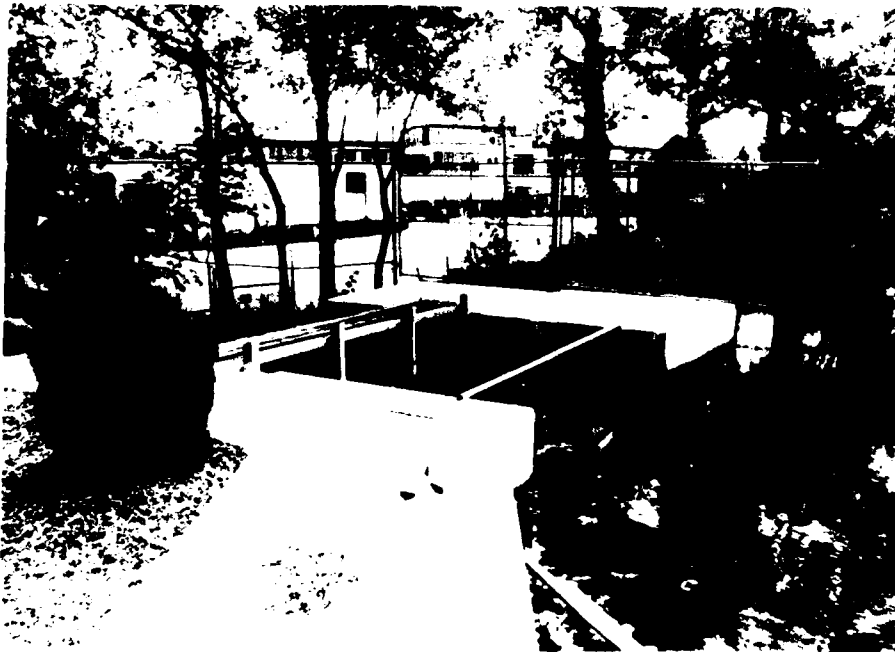
5. Right spillway walls and adjacent platform

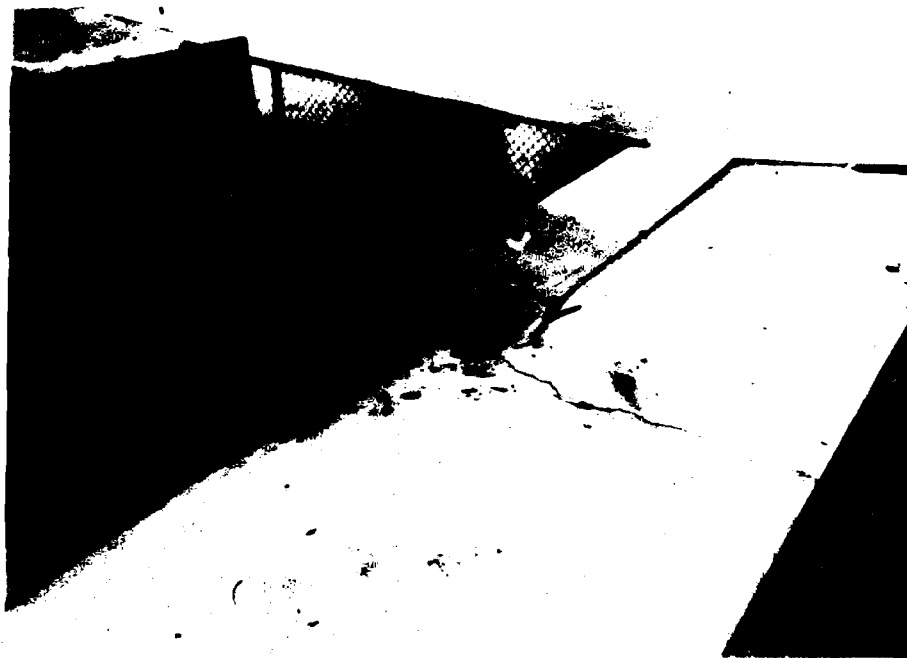
6. Service bridge bolted to older concrete walls
